## Structural Safety Inspection Report

Factory Name	Space Sweater Ltd (Jogitola)
Accord ID	23383
Factory Address	Shi-145/1, Jogitola, Joydehpur,
Date of Initial Inspection	02-Jul-2018
Date of Review Inspection	15-Mar-2020
Inspected by	Md. Abu Zafar-Al-Mansur

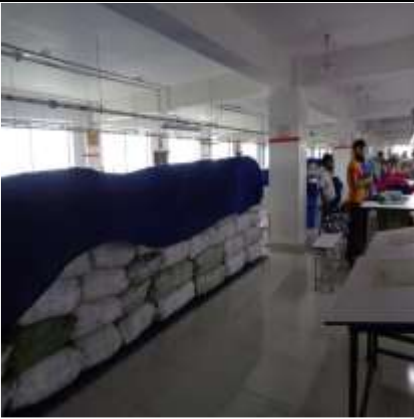
Item No	Accord Observation	Accord Recommendation	Accord Timeline	Final Action Plan	Final Timeline(dd-mmm-yyyy)	Comments after Physical Inspection	Progress Status	Pictorial Evidence
1	Foundation to be stressed above normal design limit	Maintain 3kPa live load on typical floor and 2kPa on toilet zone.	within 6 weeks	We already engage engineering consultant to do the above requirements of Detailed Engineering Assessment (DEA). Our consultant already done the DEA analysis as per Bangladesh National Building Code (BNBC) standard. After completion we already submit the DEA analysis to Accord on 9th September 2018	09-Sep-2018	<p><b>On 20/05/2019:</b> Load was found below 3 kPa on all floors and 2 kPa on toilet zone.</p> <p><b>On 15-Mar-2020:</b> Corrected from previous inspection. During inspection load was found within 3 Kpa as per accepted load plan.</p>	Corrected

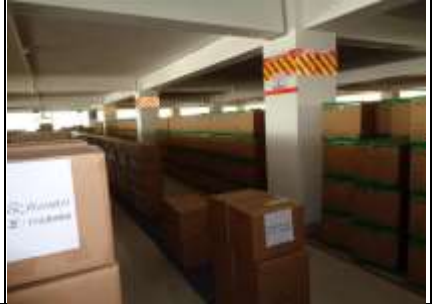
Item No	Accord Observation	Accord Recommendation	Accord Timeline	Final Action Plan	Final Timeline(dd-mm-yyyy)	Comments after Physical Inspection	Progress Status	Pictorial Evidence
3	Foundation to be stressed above normal design limit	Produce and actively manage a loading plan for all floor plates within the factory, giving consideration to floor, column and foundation capacity.	within 6 weeks	Based on this requirements we nominate a engineering consultant to do the detail engineering assessment (DEA). Our consultant done the DEA. We submitted the revised DEA to Accord on 30th January 2020	09-Sep-2018	<p><b>On 20/05/2019:</b> Load plan has been prepared as part of DEA and submitted to ACCORD on 20/12/2018 which required some revision. Factory was required to submit revised DEA to ACCORD within 20/05/2019. However, load was found below 3kPa on all floors.</p> <p><b>On 15-Mar-2020:</b> Load plan has been produced and accepted as a part of DEA. During inspection load was found within 3 Kpa as per accepted load plan.</p>	Corrected

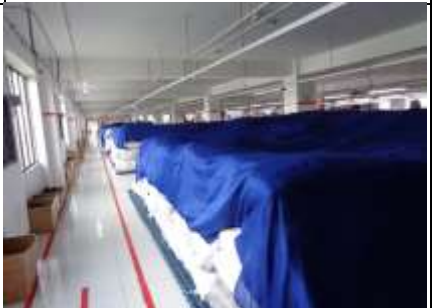
5	Foundation to be stressed above normal design limit	Continue to implement loading plan.	within 6 months	Based on this requirements we nominate a engineering consultant to do the detail engineering assessment (DEA). Our consultant done the DEA. We submitted the revised DEA to Accord on 30th January 2020	28-Feb-2019	<p><b>On 20/05/2019:</b> Load plan has been prepared as part of DEA and submitted to ACCORD on 20/12/2018 which required some revision. Factory was required to submit revised DEA to ACCORD within 20/05/2019. However, load was found below 3kPa on all floors.</p> <p><b>On 15-Mar-2020:</b> Load plan has been produced and accepted as a part of DEA. During inspection load was found within 3 Kpa as per accepted load plan.</p>	Corrected

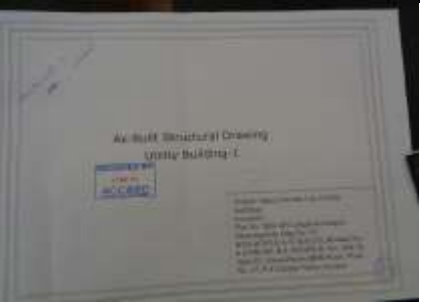
Item No	Accord Observation	Accord Recommendation	Accord Timeline	Final Action Plan	Final Timeline(dd-mm-yyyy)	Comments after Physical Inspection	Progress Status	Pictorial Evidence
6	Discrepancies between provided drawings and on site condition	Building Engineer to confirm the number of rebar in columns and prepare accurate as-built survey information for the building.	within 6 weeks	Based on this requirements we nominate a engineering consultant to do the detail engineering assessment (DEA). Our consultant done the DEA. We submitted the revised DEA to Accord on 30th January 2020	09-Sep-2018	<b>On 20/05/2019:</b> As-built drawings have been prepared as part of DEA and submitted to ACCORD on 20/12/2018 which required some revision. Factory was required to submit revised DEA to ACCORD within 20/05/2019. <b>On 15-Mar-2020:</b> As-built drawing has been produced and accepted as a part of DEA. During inspection as-built drawing was generally matched with as-built condition.	Corrected

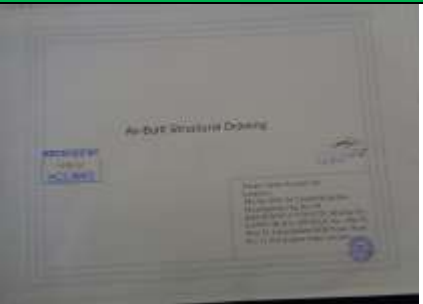
Item No	Accord Observation	Accord Recommendation	Accord Timeline	Final Action Plan	Final Timeline(dd-mm-yyyy)	Comments after Physical Inspection	Progress Status	Pictorial Evidence
10	No structural drawings for ancillary buildings.	Prepare an "as constructed" drawings which reflect the actual site dimensions with complete structural information.	within 6 weeks	Based on this requirements we nominate a engineering consultant to do the detail engineering assessment (DEA). Our consultant done the DEA. We submitted the revised DEA to Accord on 30th January 2020	10-Oct-2018	<b>On 20/05/2019:</b> As-built drawings have been prepared as part of DEA and submitted to ACCORD on 20/12/2018 which required some revision. Factory was required to submit revised DEA to ACCORD within 20/05/2019. <b>On 15-Mar-2020:</b> As-built drawing has been produced and accepted as a part of DEA. During inspection as-built drawing was generally matched with as-built condition.	Corrected

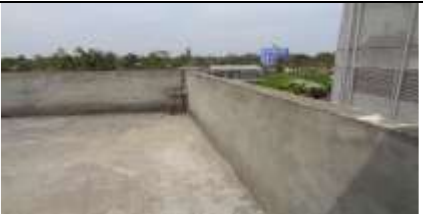
12	Expose rebar and falling hazard risk at roof.	Provide periphery railing/parapet wall to avoid possible falling hazard.	within 6 weeks	we already install railing & construct parapet wall in all required area with ensure the minimum height	10-Oct-2018	<b>On 20/05/2019:</b> Factory has provided parapet wall on the roof top to avoid possible falling. <b>On 15-Mar-2020:</b> Corrected from previous inspection. Factory has provided parapet wall at roof level to avoid falling hazard.	Corrected
