**ELECTRICAL SAFETY FOLLOW UP INSPECTION REPORT (1<sup>ST</sup>)**

<b>Factory Name</b>	Space Sweater Ltd (Jogitala)				<b>Note:</b>	
<b>Address</b>	Shi-145/1, Jogitola, Joydebpur,					
<b>FACTORY ID</b>	<b>23383</b>	<b>ELECTRICAL SAFETY INSPECTION DATES</b>				
<b>Initial Inspection Date</b>	02-Jul-2018	Date of 5 <sup>th</sup> Follow Up		Date of 11 <sup>th</sup> Follow Up	<b>Other Factory:</b> ----- ----- ----- -----	
<b>Report Received Date</b>		Date of 6 <sup>th</sup> Follow Up		Date of 12 <sup>th</sup> Follow Up		
Date of 1 <sup>st</sup> Follow Up	15-May-2019	Date of 7 <sup>th</sup> Follow Up		Date of 13 <sup>th</sup> Follow Up		
Date of 2 <sup>nd</sup> Follow Up		Date of 8 <sup>th</sup> Follow Up		Date of 14 <sup>th</sup> Follow Up		
Date of 3 <sup>rd</sup> Follow Up		Date of 9 <sup>th</sup> Follow Up		Date of 15 <sup>th</sup> Follow Up		
Date of 4 <sup>th</sup> Follow Up		Date of 10 <sup>th</sup> Follow Up		Date of 16 <sup>th</sup> Follow Up		
<b>Inspected by</b>		<b>Abu Zobair</b>

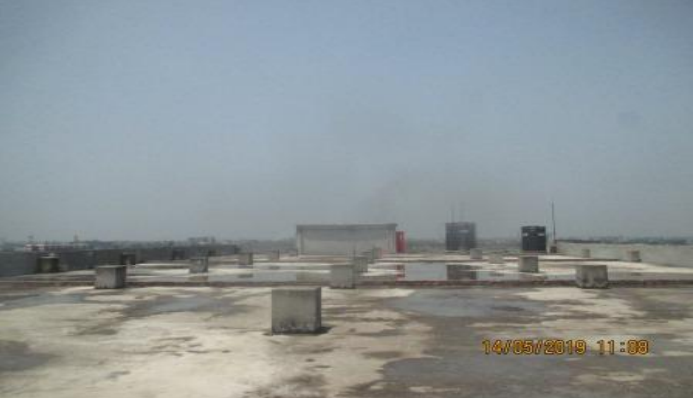
Item No	Accord Inspection Observation	Accord Action Plan (Recommendation)	Accord Time line (given in report)	Comments from Accord (After Physical Inspection)	Final Timeline (Approved timeline)	Final Action Plan (Factory)	Progress Status (On the date of inspection)	Pictorial Evidence
1	Electrical Single Line Diagram (SLD) is unavailable in the factory	As built Electrical SLD must be prepared; it must have factory's whole electrical installation information	2 MONTHS	<b>On 14/05/2019:</b> Not corrected. Factory is working on this issue.	28-Oct-2018	We are working to prepare single line diagram (SLD). After completion the SLD we will submit to Accord for review.	In Progress	
2	Lightning Protection System (LPS) installation is not completed.	Factory has to design Lightning Protection System (LPS) for the whole factory (where the Risk index is more than 40). Once LPS is designed properly, installation must be done accordingly.	3 MONTHS	<b>On 14/05/2019:</b> Corrected.	28-Nov-2018	Installation of Lighting Protection System is in progress . 70 % work already completed. Remaining work will be completed within given time frame.	Corrected

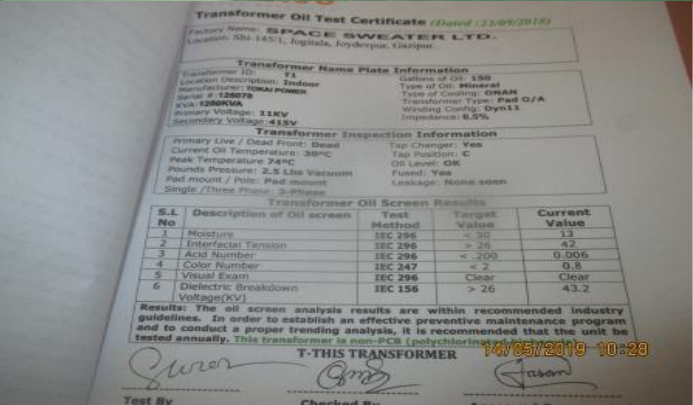
Item No	Accord Inspection Observation	Accord Action Plan (Recommendation)	Accord Time line (given in report)	Comments from Accord (After Physical Inspection)	Final Timeline (Approved timeline)	Final Action Plan (Factory)	Progress Status (On the date of inspection)	Pictorial Evidence
3	Transformer Oil Test (dielectric strength test) report is unavailable	Transformer oil test (dielectric strength test for oil) shall be done once in a year.	2 MONTHS	<b>On 14/05/2019:</b> Corrected.	28-Oct-2018	We will do the test of transformer oil according to Accord guide line.	Corrected

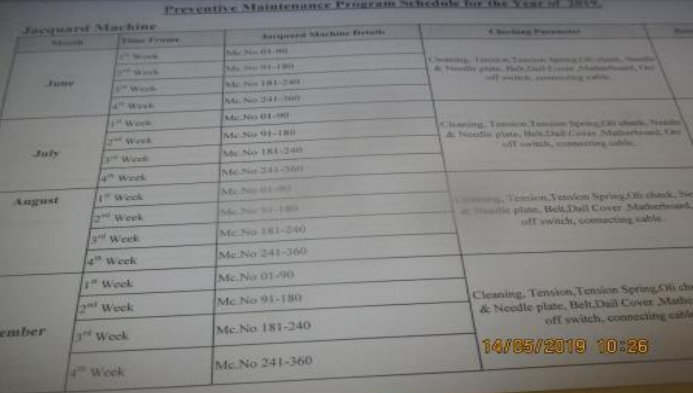
4	There is no programmed schedule for periodical inspection & testing of electrical equipment.	An electrical maintenance program shall be prepared which will include inspections and testing of the electrical systems (preventive and proactive)	2 MONTHS	<b>On 14/05/2019:</b> Corrected.	28-Oct-2018	We are working to maintain schedule of inspection & testing of electrical equipments/installations according to Accord guide line.	Corrected

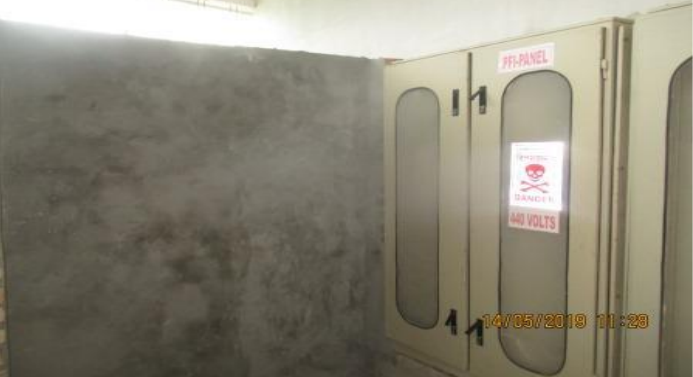
Item No	Accord Inspection Observation	Accord Action Plan (Recommendation)	Accord Time line (given in report)	Comments from Accord (After Physical Inspection)	Final Timeline (Approved timeline)	Final Action Plan (Factory)	Progress Status (On the date of inspection)	Pictorial Evidence
12	Distribution boards have no clear identification markings	All distribution boards, switchboards, sub main boards and switches shall be marked clearly for proper identification.	2 MONTHS	<b>On 14/05/2019:</b> Corrected.	28-Oct-2018	We are working to mark to all electrical distribution box. It will be complete within given time line.	Corrected

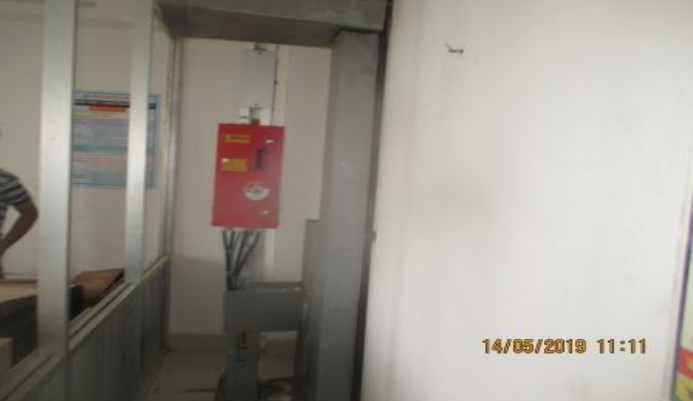
13	Instruction for CPR (Cardiopulmonary Resuscitation) or Electrical shock restoration is not present.	CPR instruction shall be hanged near all electrical installations (LT panel, MDB, FDB, DB, SDB) at visible location.	1 MONTH	<b>On 14/05/2019:</b> Corrected.	28-Sep-2018	We are working to post CPR instructions to all electrical installation/boards.	Corrected

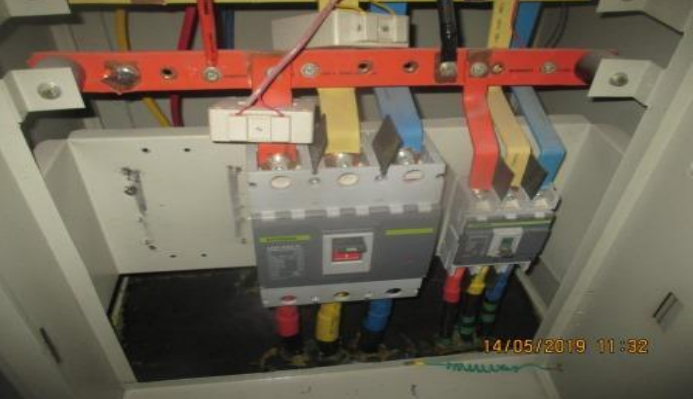
14	Panel doors are not connected with earth.	All metal installation which a part of electrical system are must be connected to earth to avoid electrical shock or electrocution.	1 MONTH	<b>On 14/05/2019:</b> Corrected.	28-Sep-2018	We are working to connect ear thing to all door of electrical panel boards.	Corrected

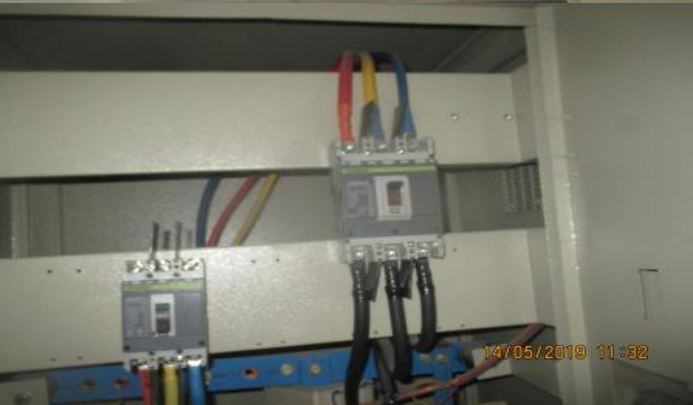
Item No	Accord Inspection Observation	Accord Action Plan (Recommendation)	Accord Time line (given in report)	Comments from Accord (After Physical Inspection)	Final Timeline (Approved timeline)	Final Action Plan (Factory)	Progress Status (On the date of inspection)	Pictorial Evidence
15	Phase barrier/separators are missing in MCCBs.	Phases must be separated by insulator (a rubber type no-flammable material shall be used for it).	1 MONTH	<b>On 14/05/2019:</b> Corrected.	28-Sep-2018	We will provide phase separator to all MCCBs.	Corrected	 
16	Panel base plates are removed to allow cable entry.	Panel base plates must be installed, at all time, and cables entering panel must be firmly fixed with cable gland.	2 MONTHS	<b>On 14/05/2019:</b> Corrected.	28-Oct-2018	We will install base plate including cable gland to all required area.	Corrected	 
17	Power cables are bent excessively.	Power cables must be installed as straight as possible; in unavoidable case, not less than 135-degree bending can be allowed.	2 MONTHS	<b>On 14/05/2019:</b> Corrected.	28-Oct-2018	We will remove cable bending from electrical board.	Corrected

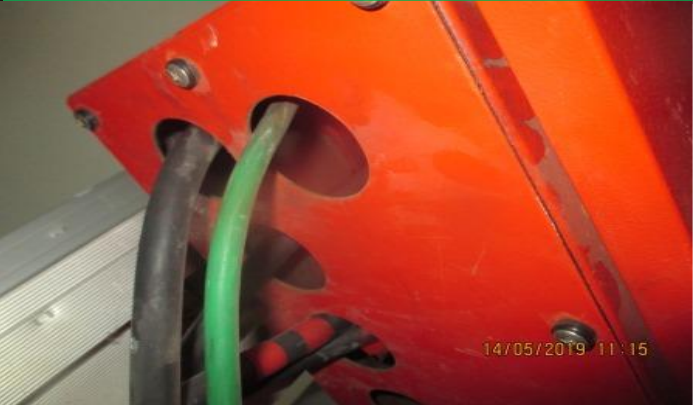
Item No	Accord Inspection Observation	Accord Action Plan (Recommendation)	Accord Time line (given in report)	Comments from Accord (After Physical Inspection)	Final Timeline (Approved timeline)	Final Action Plan (Factory)	Progress Status (On the date of inspection)	Pictorial Evidence
18	Distribution Board's top/bottom is left open.	Each electrical distribution board/panel must be properly sealed to avoid ingress of fluffs; but an adequate ventilation system must also be ensured. Gland shall be used, where required.	2 MONTHS	<b>On 14/05/2019:</b> Not corrected. Factory is working on this issue.	28-Oct-2018	We will seal all distribution board open area.	In Progress

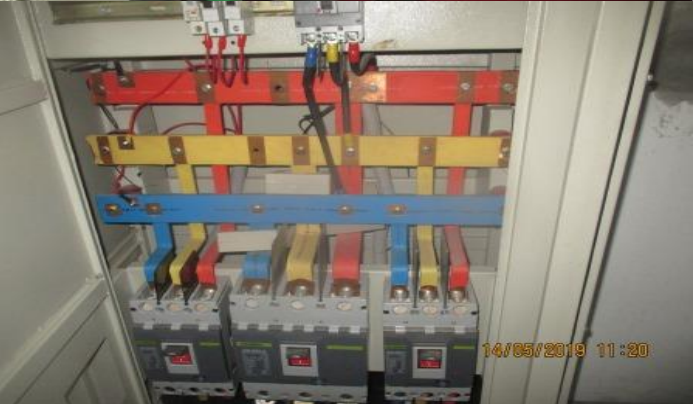
19	Unterminated live wire is kept inside the electrical panel.	All the unterminated live power cables must be removed as soon as possible.	1 MONTH	<b>On 14/05/2019:</b> Corrected.	28-Sep-2018	We will remove all unterminated live power cable .	Corrected

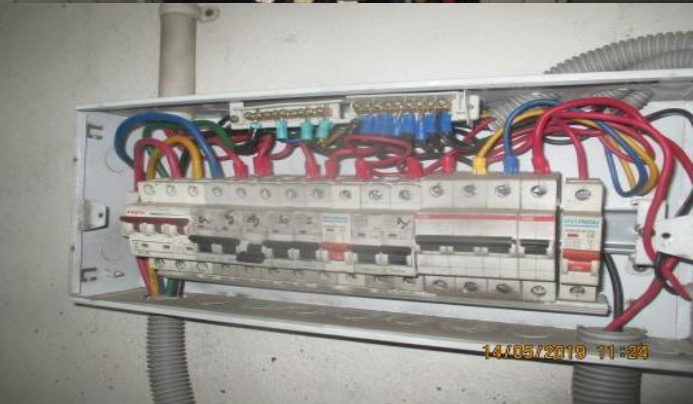
20	Cables in service are joined (splicing) between terminations.	Splicing in the power cables shall be avoided; in unavoidable cases splicing, must be made following proper guidance.	2 MONTHS	<b>On 14/05/2019:</b> Corrected.	28-Oct-2018	We will separated the all power cable & service by following proper guideline.	Corrected

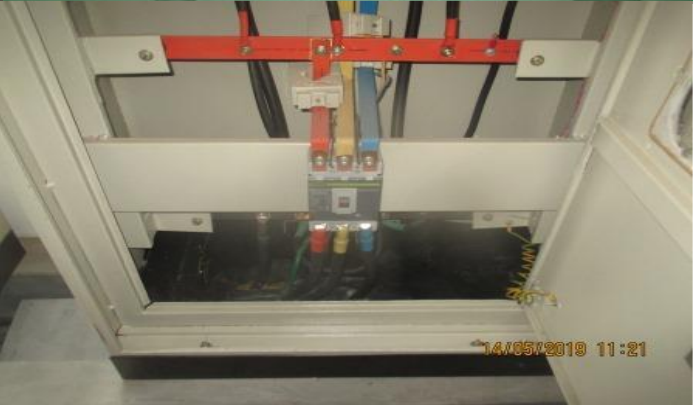
Item No	Accord Inspection Observation	Accord Action Plan (Recommendation)	Accord Time line (given in report)	Comments from Accord (After Physical Inspection)	Final Timeline (Approved timeline)	Final Action Plan (Factory)	Progress Status (On the date of inspection)	Pictorial Evidence
21	MCCBs are not adjusted per load demand.	All the MCCBs must be adjusted per connected load current; if adjustment is not possible, replacement will be the only way.	2 MONTHS	<b>On 14/05/2019:</b> Corrected.	28-Oct-2018	We will adjust all MCCBs according to load plan.	Corrected

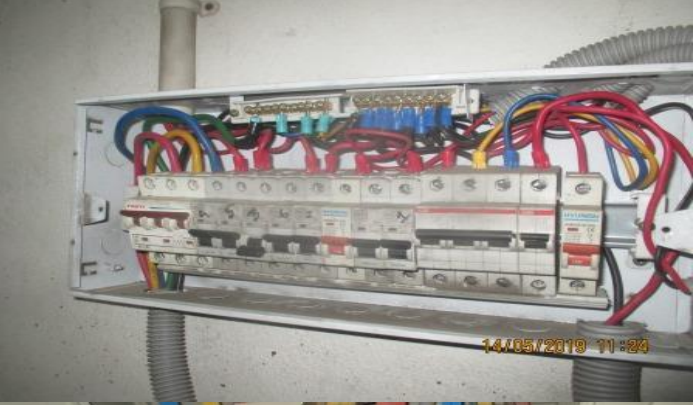
22	Loop connection has been used powering multiple circuits through MCB/MCCBs.	No loop connection shall be used; each single cable shall be terminated using cable lug (flat/I) at each terminal. Combo bus bar may be used (but incoming cable size must meet the rated capacity).	2 MONTHS	<b>On 14/05/2019:</b> Corrected.	28-Oct-2018	We will remove all loop connection and will provide cable lug to each cable separately.	Corrected

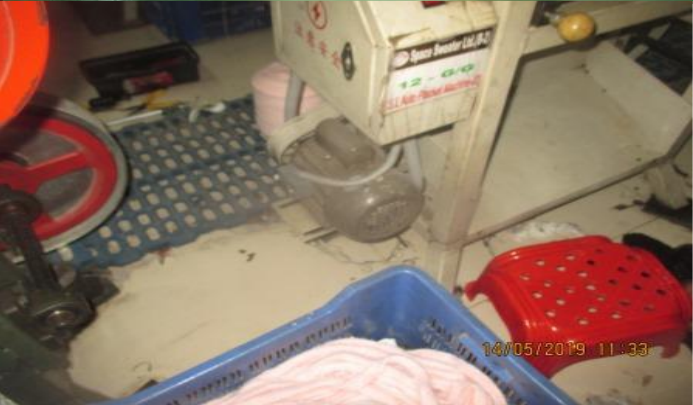
Item No	Accord Inspection Observation	Accord Action Plan (Recommendation)	Accord Time line (given in report)	Comments from Accord (After Physical Inspection)	Final Timeline (Approved timeline)	Final Action Plan (Factory)	Progress Status (On the date of inspection)	Pictorial Evidence
27	Cable directly connected with motor coil without terminal box.	Cable must be connected through motor terminal box as manufacturer guideline.	3 MONTHS	<b>On 14/05/2019:</b> Corrected.	28-Nov-2018	We will use motor terminal box to connect the cable line for motor.	Corrected

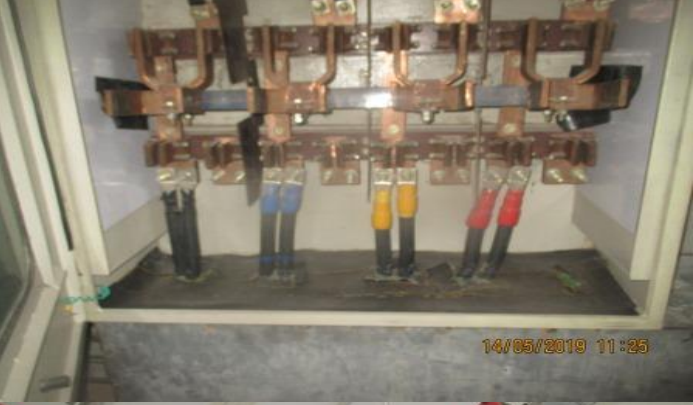
28	Generator output cables (laid on floor) are not protected and supported.	Service cables from generator must be supported at its own breaker's terminal and with cable tray.	2 MONTHS	<b>On 14/05/2019:</b> Corrected.	28-Oct-2018	We will provide cable tray for cable transfer in generator room.	Corrected

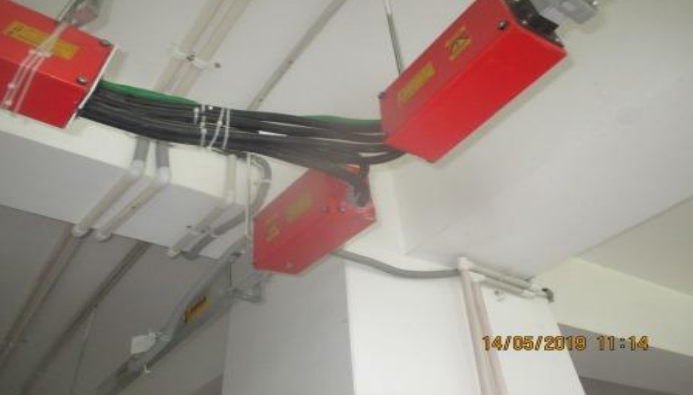
29	BBT feeder box/tap off box left open for ingress of lint, dust or fluffs.	Feeder box/tap off box must be properly sealed to avoid ingress of any foreign particles.	2 MONTHS	<b>On 14/05/2019:</b> Corrected.	28-Oct-2018	We will seal all BBT feeder box/tap to avoid enter the out side dust.	Corrected

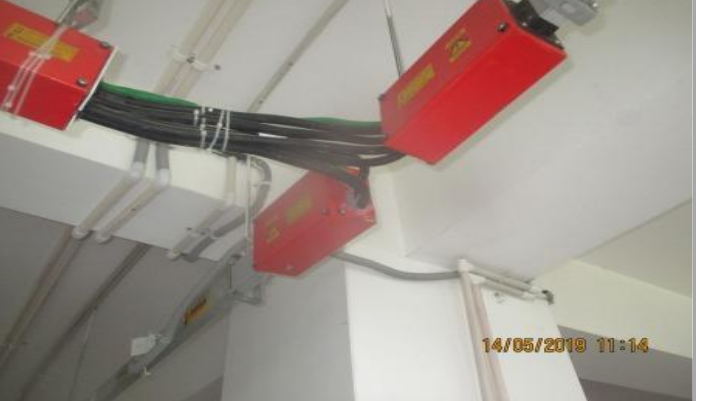
Item No	Accord Inspection Observation	Accord Action Plan (Recommendation)	Accord Time line (given in report)	Comments from Accord (After Physical Inspection)	Final Timeline (Approved timeline)	Final Action Plan (Factory)	Progress Status (On the date of inspection)	Pictorial Evidence
30	Feeder box/tap off box must be properly sealed to avoid ingress of any foreign particles.	Power cables must be supported by cable tray (ladder- where needed). Outdoor arrangement must be covered.	2 MONTHS	<b>On 14/05/2019:</b> Corrected.	28-Oct-2018	We will provide cable tray to proper hanging of power cable in wash section.	Corrected

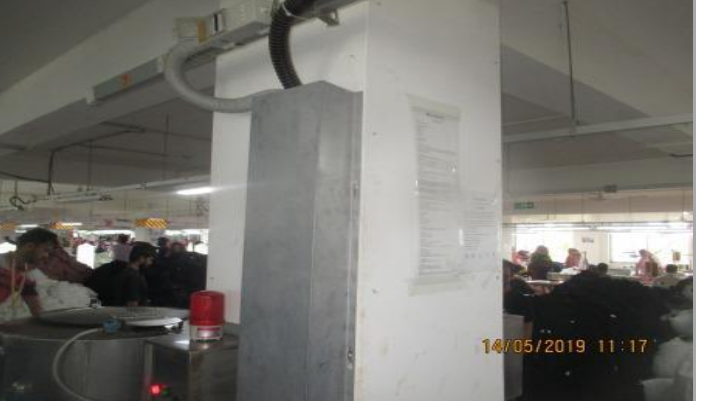
31	Wiring or extensions to connect equipment/ devices are laid on floors unprotected in flexible PVC.	The cable connection to machines/equipment may be run under the checkered plates (existing) and in trenches or rigid conduits/cable trays and supports to protect from external damages.	2 MONTHS	<b>On 14/05/2019:</b> Corrected.	28-Oct-2018	We will provide proper support for power cable to avoid external damage in winding section.	Corrected

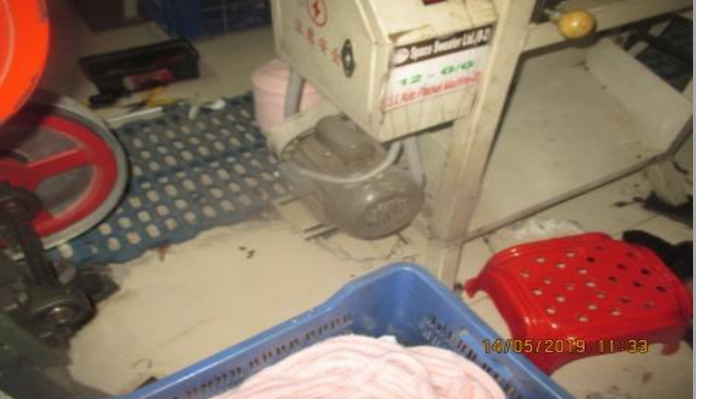
32	Capacitor on motor attached with combustible material and tied with rope.	Capacitor must be free from combustible and fix by permanent means.	2 MONTHS	<b>On 14/05/2019:</b> Corrected.	28-Oct-2018	We already removed combustible material from capacitor of motor and fix by required permanent system.	Corrected
