FIRE SAFETY FOLLOW UP INSPECTION

Factory Name	Space Sweater Ltd (Jogitola)		Factory ID	23383
Address	Shi-145/1, Jogitola, Joydebpur,			
Initial Inspection Date	02 Jul 2018		Report Received Date	
Date of 1st Follow-up	14-May-2019	Date of 2nd Follow-up	19-Mar-2020	
Date of 3rd Follow-up	12-Dec-2021	Date of 4th Follow-up	04-Sep-2022	
Date of 5th Follow-up	09-Mar-2023	Date of 6th Follow-up	02-Apr-2024	
Date of 7th Follow-up		Date of 8th Follow-up		
Date of 9th Follow-up		Date of 10th Follow-up		
Date of 11th Follow-up		Date of 12th Follow-up		
Date of 13th Follow-up		Date of 14th Follow-up		
Date of 15th Follow-up		Date of 16th Follow-up		
Date of 17th Follow-up		Date of 18th Follow-up		
Date of 19th Follow-up		Date of 20th Follow-up		
Inspected by	Md. Kawsar Rubaiat

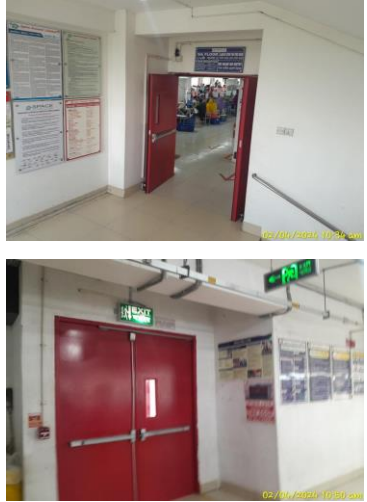
Item No	Inspection Observation	Inspection Recommendation	Timeline given	Comments after Physical Inspection	Supposed to complete(DD/MM/YYYY)	Final Action Plan (Factory)	Status on the date of Inspection	Pictorial Evidence
18	New Finding (2nd Follow up): The exit stair enclosures are not separated from work areas by fire-rated construction at utility building.	Provide minimum 1-hr fire rated doors and seal all unprotected openings to separate the exit stairs from work areas and other building spaces on all floor levels. Ensure that the fire rated doors are self-closing and positive latching and that they are provided with fire exit (panic) hardware where serving production floors. If fire rated doors are required to be held open for functional reasons, provide automatic closing devices tied to the fire alarm system. Once fire doors are installed, every door in a stair enclosure serving more than 5 stories shall be provided with re-entry unless it meets ACCORD standard 6.8.3.1 If fire doors are required to be held open for functional reasons, provide automatic-closing devices tied to the fire alarm system.	Within 2 Months	On 19/03/2020: New Finding On 31/08/2021 (Special Inspection): Not verified. On 12/12/2021: Corrected. On 04/09/2022: Corrected. On 09/03/2023: Corrected. On 02/05/2023(Special Inspection): Not verified. On 02/04/2024: Corrected.	19/May/2020	The exit stair enclosures separation by fire rated materials at Utility Building (1st Floor) has already done. This work completed on 30 April, 2020.	Corrected

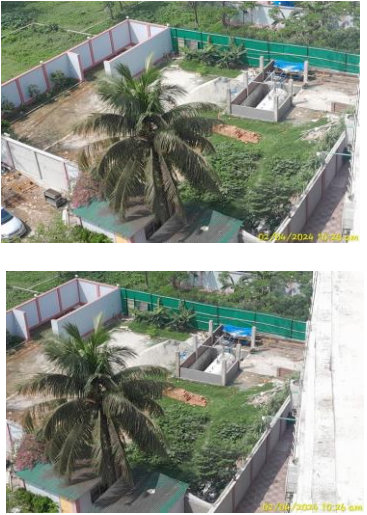
19	New Finding (2nd Follow up): LPG cylinders were located within the factory.	The storage or use of LPG or CNG cylinders shall be prohibited within the factory building according to Accord 3.4.2.1.11.	Immediate	On 12/12/2021: No visual progress observed. On 04/09/2022: Factory management relocated the CNG van (48 CNG cylinders) outside to factory into another plot but adjacent to public road. The plot is in the opposite side of the factory building and the public road is in-between factory building and empty plot (different landowner). For the interim period till to get natural gas connection factory management is recommended to set the CNG van inside of the empty plot keeping spatial distance of minimum 9 m surrounding of CNG van, they also have to ensure that the surroundings (within 9 m) of the CNG van is never occupied for any other occupancy. On 09/03/2023: Found same as previous follow-up inspection. Reportedly the factory is planning to relocate the cylinders. On 02/05/2023(Special Inspection): During the inspection it has been found that the factory management purchase new land beside their existing factory premises & put the CNG pickup (48 CNG cylinders) inside that land without any fire separated room. As the land is merged & opened with the existing factory premises, so in practical the CNG pickup is found inside the factory premises. As per standard requirement the CNG is prohibited inside the factory premises & As per "Supplementary Paper on Technical Guidance Note: For Use of Liquefied or Compressed Flammable Gas in Factory Premises" The factory shall provide 2-hr fire separated room with a fire door and protection of all openings, penetrations & ducts to maintain the 2-hour fire resistance/ fire separation, Storage rooms for cylinders shall have to keep in dry, cool, and well ventilated condition. Which all are not maintained. RPO Comments On 18-Feb-2024: The factory management reported that they have corrected this issue. After reviewing the pictorial evidence, the Engineer recommended for the physical inspection to verify its verification. This item will be verified in the next inspection. On 02/04/2024: Corrected. The factory has maintained a spatial distance of a minimum of 9m around the CNG pickup point and placed it outside the factory premises. They have also ensured that no access route was provided from the factory to the CNG pickup point.	24/Mar/2020	We have removed LPG Cylinder storage Station from factory premises. This issue is completed.	Corrected
