### ELECTRICAL SAFETY FOLLOW UP INSPECTION REPORT (3RD)

<b>Factory Name</b>	Space Sweater Ltd (Jogitala)				Note:
<b>Address</b>	Shi-145/1, Jogitola, Joydebpur,				
<b>FACTORY ID</b>	<b>23383</b>	ELECTRICAL SAFETY INSPECTION DATES			
<b>Initial Inspection Date</b>	02-Jul-2018	Date of 5 <sup>th</sup> Follow Up	Date of 11 <sup>th</sup> Follow Up	Date of 17 <sup>th</sup> Follow Up	Other Factory:
<b>Report Received Date</b>	19-Aug-2018	Date of 6 <sup>th</sup> Follow Up	Date of 12 <sup>th</sup> Follow Up	Date of 18 <sup>th</sup> Follow Up	
Date of 1 <sup>st</sup> Follow Up	14-May-2019	Date of 7 <sup>th</sup> Follow Up	Date of 13 <sup>th</sup> Follow Up	Date of 19 <sup>th</sup> Follow Up	
Date of 2 <sup>nd</sup> Follow Up	17-May-2022	Date of 8 <sup>th</sup> Follow Up	Date of 14 <sup>th</sup> Follow Up	Date of 20 <sup>th</sup> Follow Up	
Date of 3 <sup>rd</sup> Follow Up	04-Sep-2022	Date of 9 <sup>th</sup> Follow Up	Date of 15 <sup>th</sup> Follow Up	Date of 21 <sup>st</sup> Follow Up

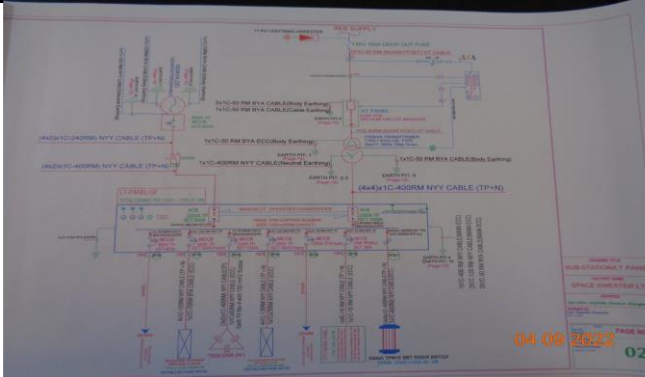
Item No	Inspection Observation	Inspection Action Plan (Recommendation)	Inspection Time line (given in report)	Inspection Comments (After Physical Inspection)	Factory Timeline (Approved timeline)	Final Action Plan (Factory)	Progress Status (On the date of inspection)	Pictorial Evidence
1	Electrical Single Line Diagram (SLD) is unavailable in the factory	As built Electrical SLD must be prepared; it must have factory's whole electrical installation information	2 MONTHS	On 14/05/2019: Not corrected. Factory is working on this issue. On 17-May-2022: Not Corrected. Still some work is pending. SLD is needed to be reviewed by RSC. Comments by CH on 14/8/22: Progress status will be changed to PV when SLD is accepted. <b>On 04/09/2022:</b> Not Corrected. Some progress has been observed. Factory is working to update SLD.	28-Oct-2018		In Progress
